# Lakeside Patio, Lawn Repair Do More Than Restore

Source: [www.TurfMagazine.com](http://www.TurfMagazine.com)

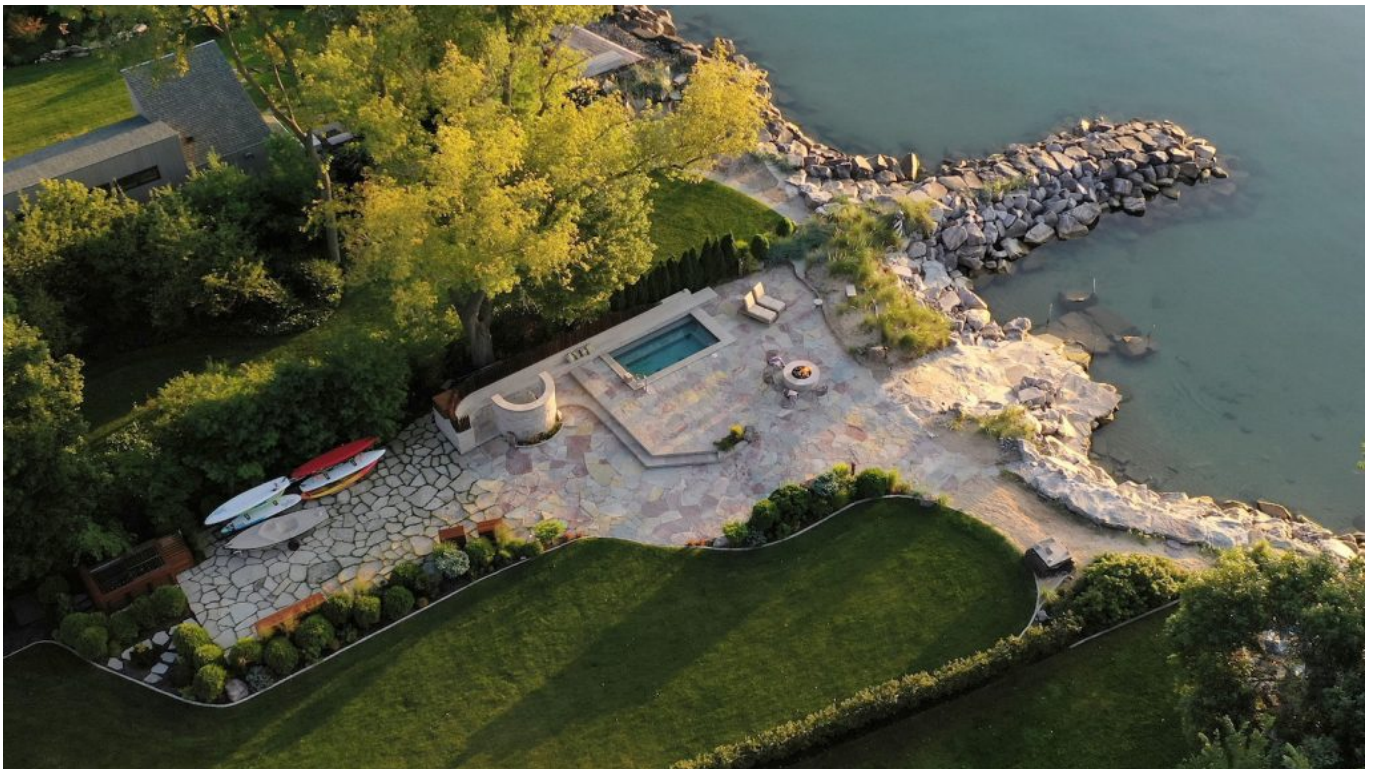
On the shore of Lake Michigan, Nature's Perspective Landscaping of Evanston, IL worked to create a new stone patio with jacuzzi, outdoor shower, fire pit, and watercraft storage area.

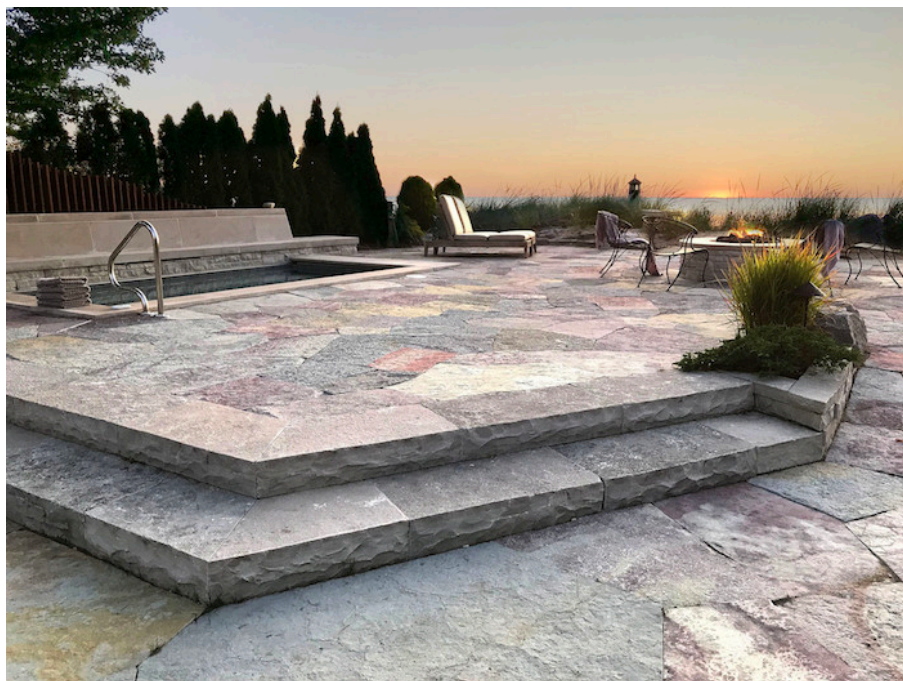
"Our bigger job was to get the area back together," Klitzkie says. "We did some extensive grading but pretty much everything else is new."

"The client had recently completed a large restoration project along the lakefront spanning several different properties," explains Tim Benz, who worked with the owner on the design of the project. "Construction access to the lake had been through our client's property, so the driveway, rear yard, and lake front had been damaged and needed to be restored."

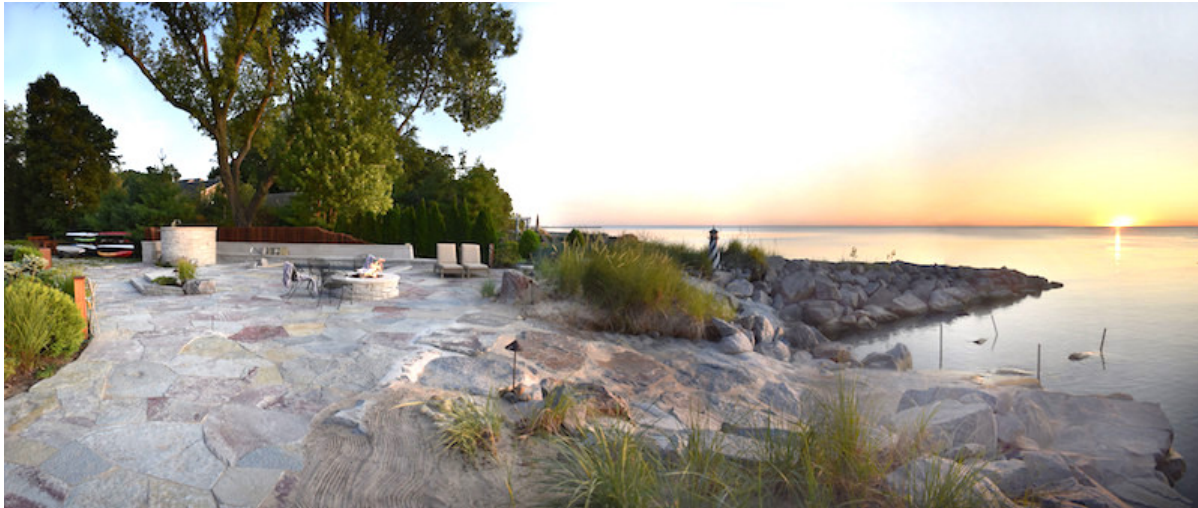
"Because of the water that will be pouring off these boats, we changed the pattern over the course of the patio," says Benz. "Around the patio, it's a crazy-quilt pattern with tight joints. With the boat storage, it's more loosely laid so the water can get out of the area."

Benz adds that most of the patio is Chilton stone in a crazy quilt pattern allows for tighter joints for the jacuzzi and shower area because the client wanted to be able to walk on it in bare feet without running the risk of stubbed toes. The one exception to the sand-set stone is in the area of the outdoor shower, which is one step up and mortar-set. The Chilton stone was also used for the firepit and large spa, with coping and the bench along one edge of the property machine-cut from Indiana limestone.

The choice of Eden-Valders' product, Chilton Stone, was an easy one. The Chilton is known for its plum and lilac tones. Utilizing flagstone that was hand-fitted and sand-set, the company crafted a patio that morphs into storage for personal watercraft as it moves farther away from the lakeshore.

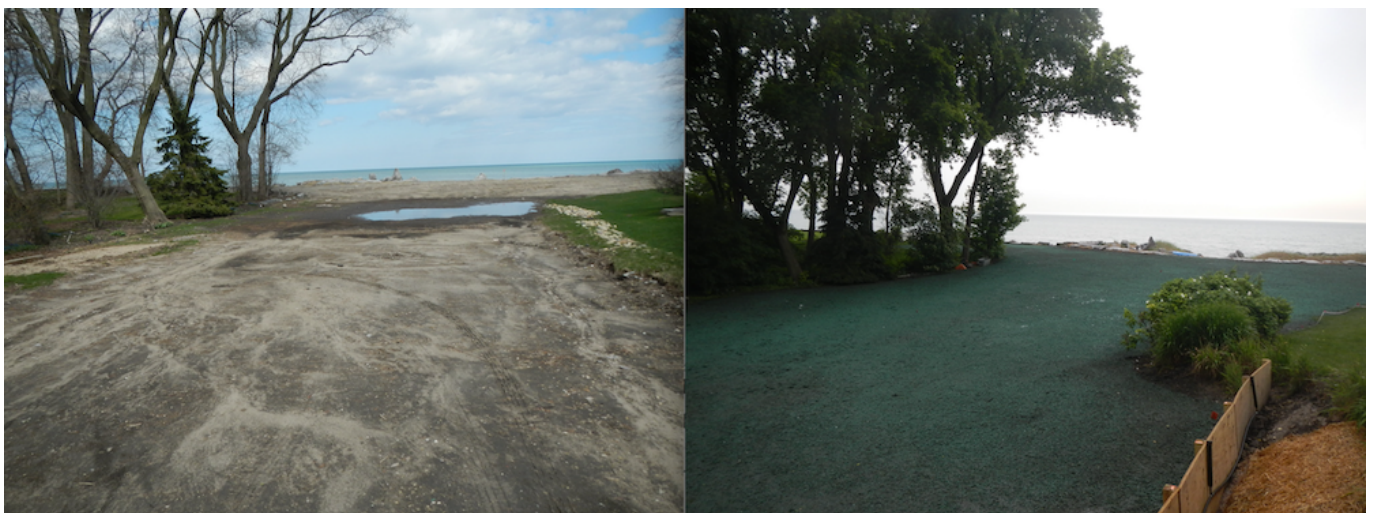
## Lawn repair (before and after)

"The lake is about six feet lower than the highest point of the patio, and then the yard drops back down before rising again toward the house," he says. "In the middle of construction, the vehicular traffic compacted the soil and turned it into a lake, so we did an extensive amount of remediation."

The soil is quite sandy, and Benz says the main remediation was the installation of drainage and re-sodding.

"The client has had 13-foot waves crashing over the front revetment wall, washing up extensive amounts of sand from the beach area, but the Chilton stone is holding up beautifully," Benz says. "Even with this extreme amount of water, the drainage system has been able to handle it and cope with the volume."

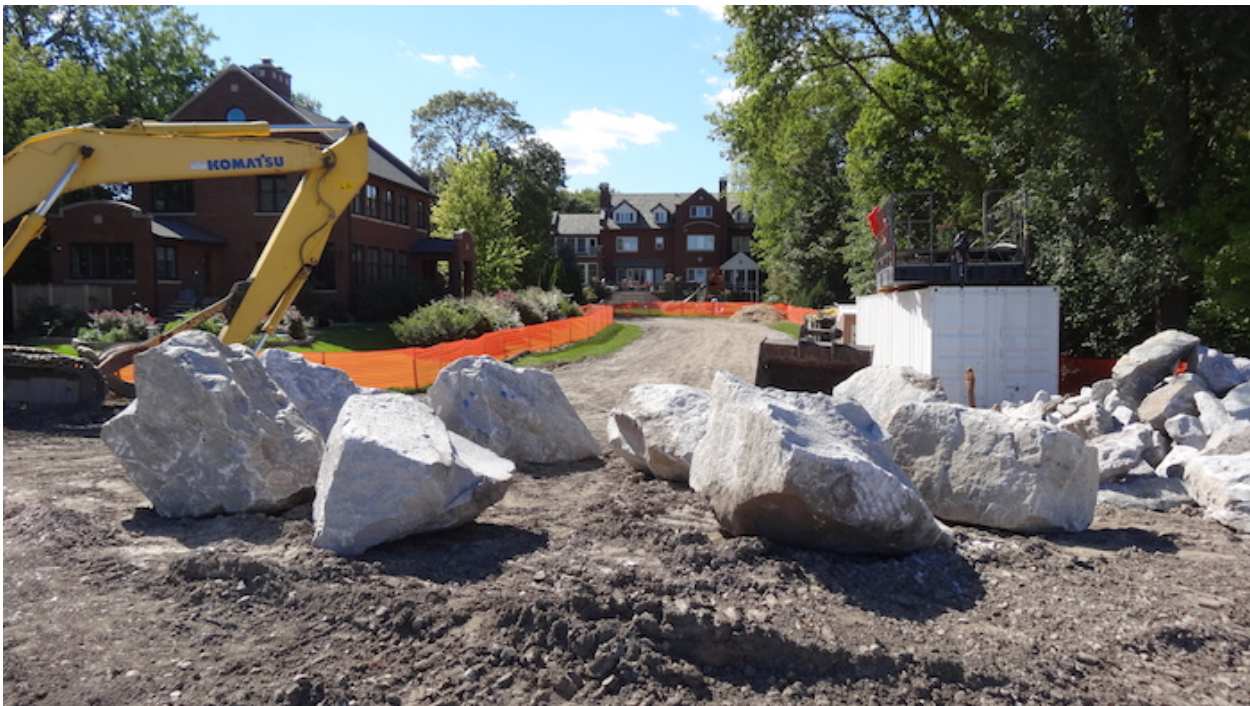
Despite the crew working with some flagstones that weighed as much as 500 pounds, Benz says probably the most challenging part of the job was the lake and Mother Nature. Klitzkie agrees, and explains it wasn't uncommon for the lake to be calm at 8 a.m., only to have four- and five-foot waves crashing by mid-morning.
