# Block Retaining Wall Saves The Day At Vacation Home

***For a central Wisconsin vacation home, Paul's Landscaping of Vesper, WI designed a block retaining wall to replace a failing railroad tie installation. Including a turret in the design sealed the deal for this prize-winning project.***

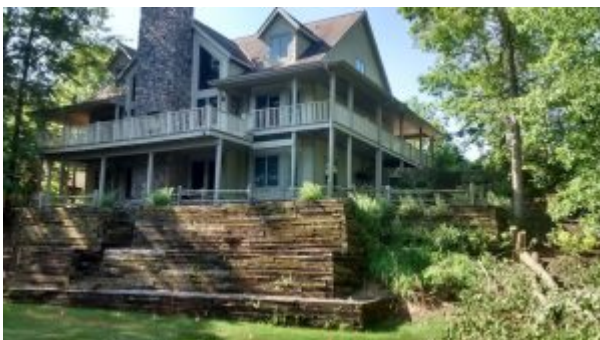
Mark Paul, owner of Vesper, WI-based Paul's Landscaping, estimates the owners had no more than 18 months before their deck and back of the house collapsed. The culprit: a railroad-tie retaining wall system installed in 1994 which was falling apart.

"The sand was leaking through it; it was failing miserably," says Paul. "The pavers that were under the deck were sinking, and the whole thing just wasn't doing the job."

Before: Installed in 1994, this railroad tie retaining wall was in danger of eventual collapse.

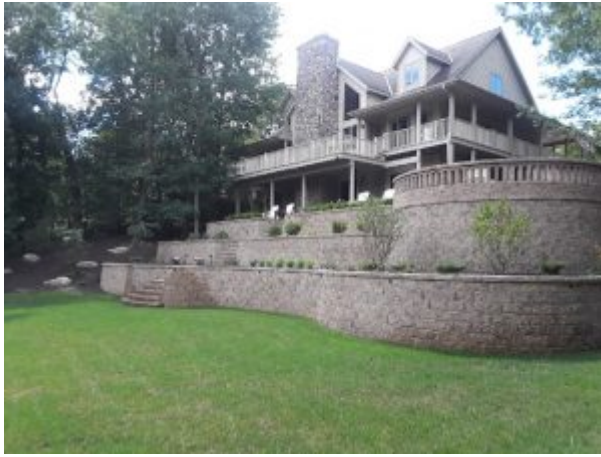
After: Paul's Landscaping spearheaded the design and construction of a block retaining wall measuring 12.5' high.

By comparison, installing the new retaining wall was relatively easy. The work was done in three terraced levels totaling 12.5' in height with block from Marathon, WI-based [County Materials Corp.](#) Paul says the job used the company's regular pinned block which measures 12" X 12" X 8".

"County Materials recommends you don't go any higher than eight courses before you step back," Paul says. "We ran geogrid every two courses, but the other reason for the terracing is so the stairs would have landings."

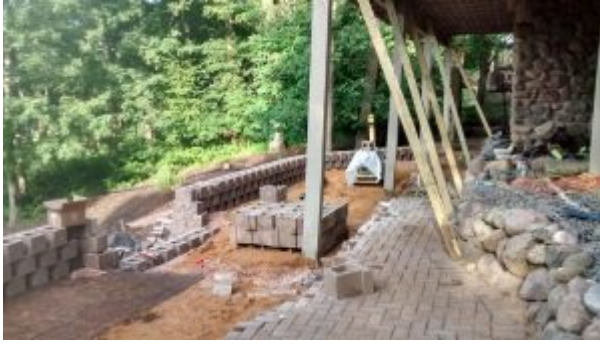
However, removing the old timbers and hauling them away proved to be easy compared with what Paul says by far was the most challenging aspect of the job. The 50-foot wide deck was supposed to be supported by nine 6" X 6" posts set on concrete pylons, but by that point that wasn't always the case.

"Because the wall was failing, the ground level had sunk about three inches and was moving away from the house," Paul explains. "We had to prop the deck up with temporary bracing so we could dig out the old pylons and pour new ones. The deck then had to be releveled and the posts replumbed because they were no longer straight up and down."

The deck on the home was propped up with temporary bracing, so the contractor could dig out the old pylons and pour new ones. (Photo: Paul's Landscaping)

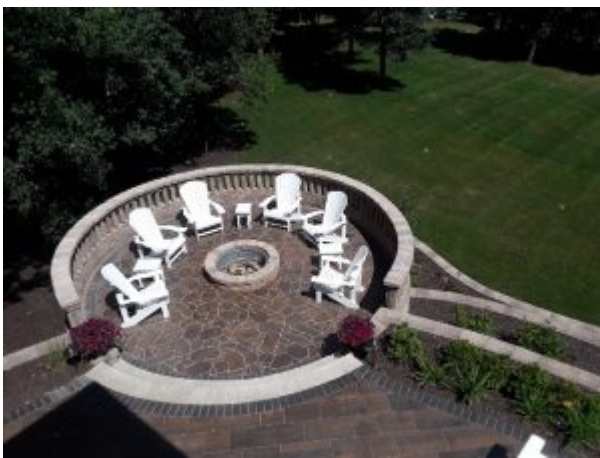
Set off from the patio about 10 feet above the grade of the lowest terrace, the turret is 20 feet in diameter and contains both the wood-burning firepit and plenty of seating all resting on County Materials' Destination flagstone-looking pavers.

The turret surrounding the new firepit area was not part of the initial design plan. (Photo: Paul's Landscaping)

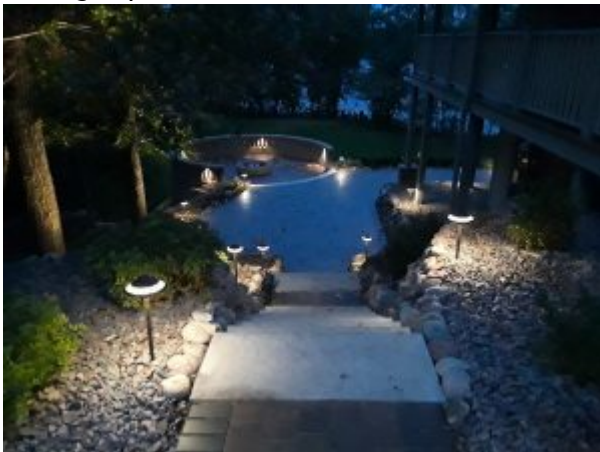
Low voltage lighting leads the way down to the firepit. (Photo: Paul's Landscaping)
